Manhole Inspection Summary

Manhole # S25GG2017MH

Location Address: **808 LAKE AVE**

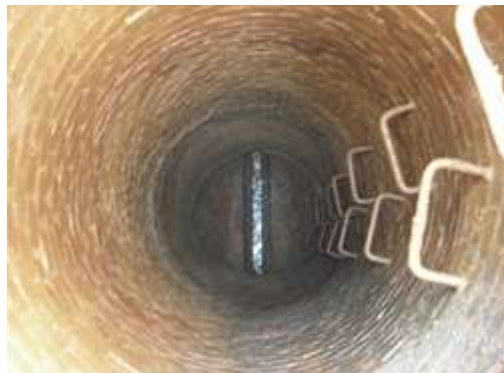
Top View

Adjustment, Corbel, and Barrel infiltration. Corroded steps. Evidence of surcharge - Bench debris.

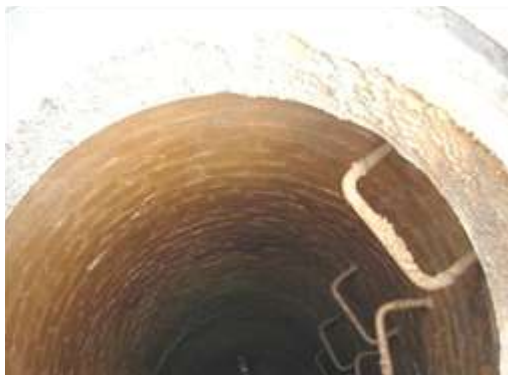
Defect

Frame leaks. Adjustment infiltration.

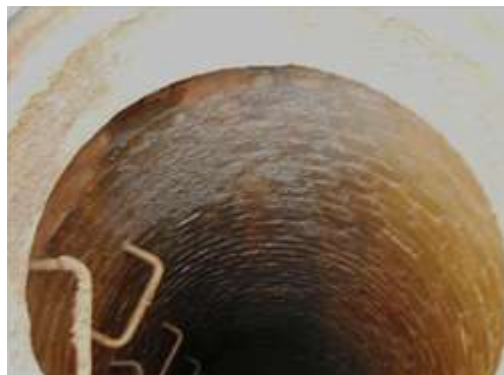
Defect

Frame leaks. Adjustment and Corbel infiltration.

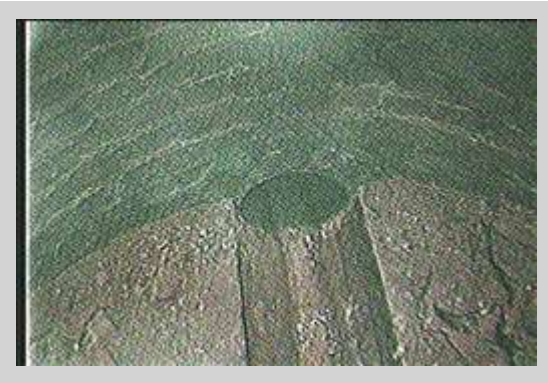
10 in. Circular Gravity Sewer Pipe Out @ 12 O'Clock

Barrel deterioration and infiltration.
